Manhole Inspection Summary

Manhole # S55C__029MH

Insp Date: **6/20/08 1:35 PM**

Location Address: **rear 3537 e fairmount ave**

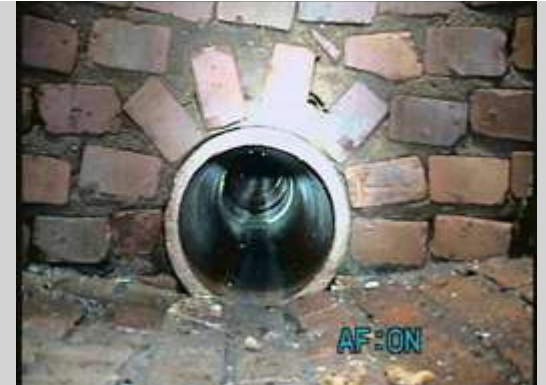
12 O'Clock Outflow

8 in. Circular Gravity Sewer
Pipe Out @ 12 O'Clock

Pipe Material: **Clay** ☐ Pipe Lined

Invert Depth: 9.61 (ft.) Flow Characteristics: **Slow**

Infiltration: **None** Pipe Seal Cond: **Unknown**

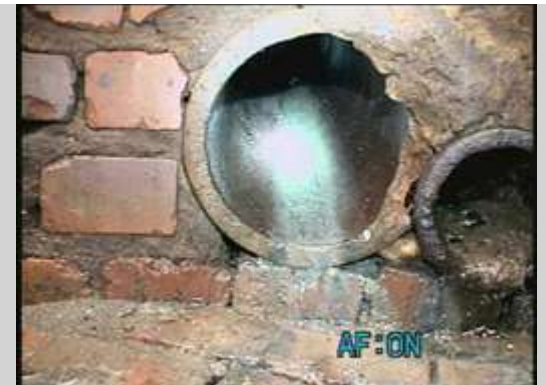
8 O'Clock Inflow

8 in. Circular Gravity Sewer
Pipe In @ 8 O'Clock

Pipe Material: **Clay** ☐ Pipe Lined

Infiltration: **None** Pipe Seal Cond: **Unknown**
